RADC-TR-75-50  
Final Technical Report  
March 1975

RELIABILITY STUDY OF BEAM LEAD SEALED JUNCTION DEVICES  
Hughes Aircraft Co.

The major study conclusions point out limitations in the test devices in several areas. There were some problems associated with manufacturing defects, such as cracked silicon nitride layers, gold plating defects and possibly junction shorts arising from defective barrier layers and subsequent gold-silicon interaction. There were also fundamental materials problems such as gold deplating in moist environments and surface instabilities of linear devices.

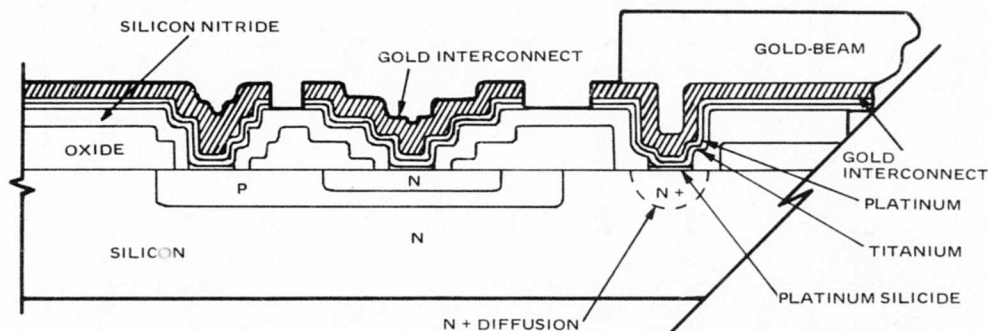
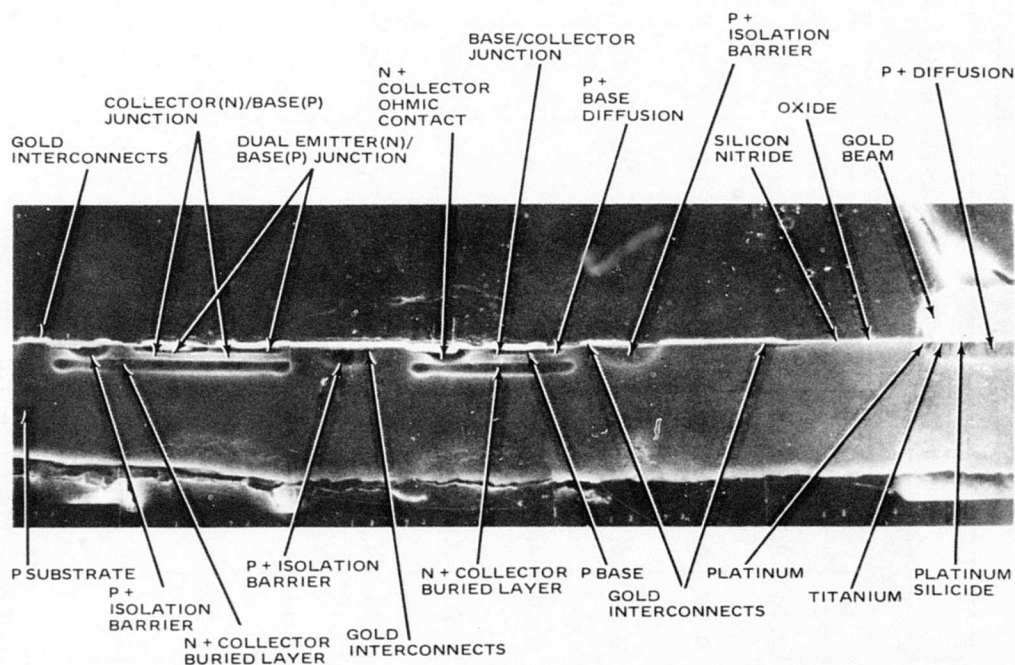
Figure 21. Cross-Section of a Typical Beam Lead Device

(a) Desired Cross-Section Fabricated According to Bell Labs Metallurgical Requirements (Thickness Exaggerated for Clarity)

(b) SEM Photograph of Beam Lead Device Cross-Section (Dual J-K Flip-Flop) Showing Interconnect Metallurgy and Device Junctions

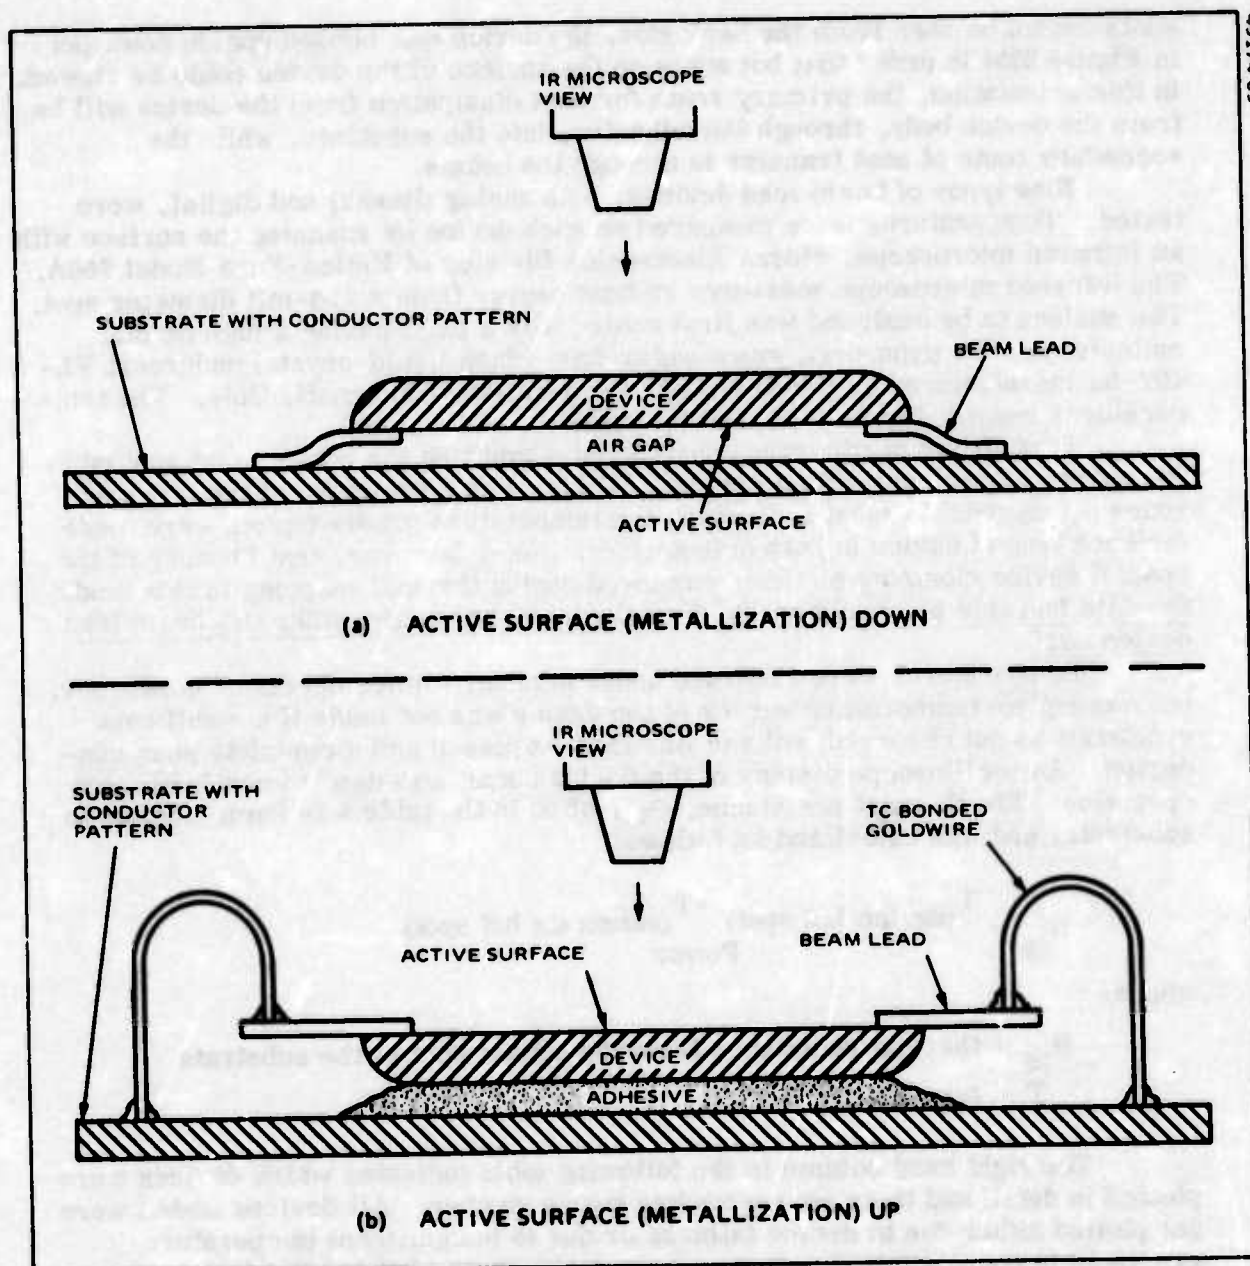
Figure 22. Two Orientations Used in Thermal Mapping Analysis. Metallization down is the normal orientation for mounting beam lead devices, but this does not present an active surface view for the IR microscope. Mounting with metallization up enabled hot spots on the device surface to be plotted.

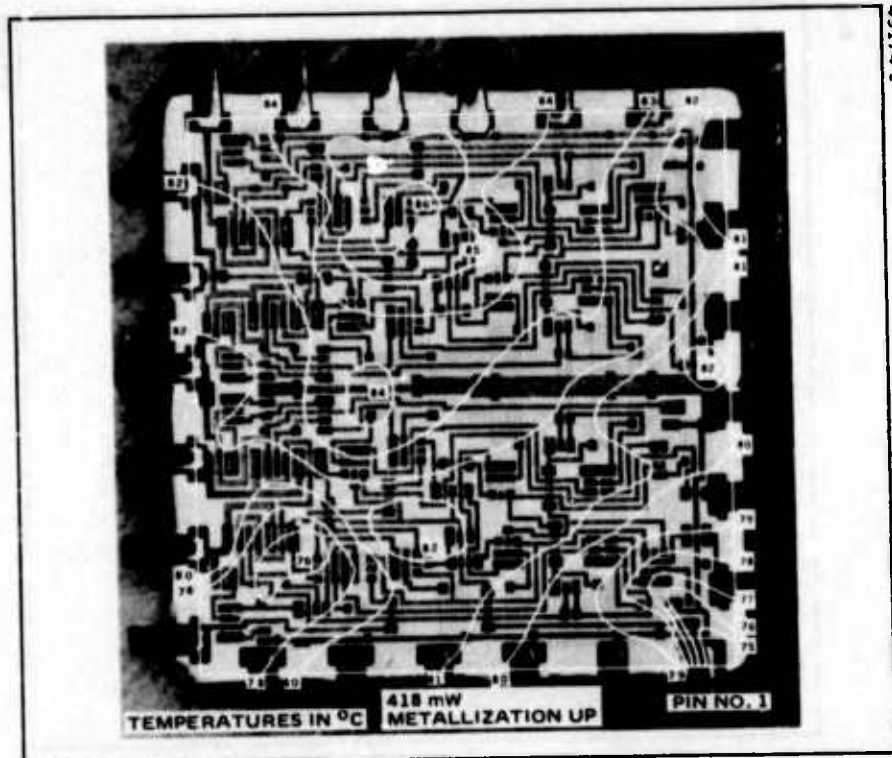
Figure 23. Digital Beam Lead Device SC148, S/N 1

Figure 23 shows typical temperature distribution with high power. Failure of diodes in the vicinity of the 86° region (in upper center) has been observed. Hot spots in Figure 24 generally cannot be observed due to the heat spreading effect of the thick silicon material. (Compare with Figure 23.)

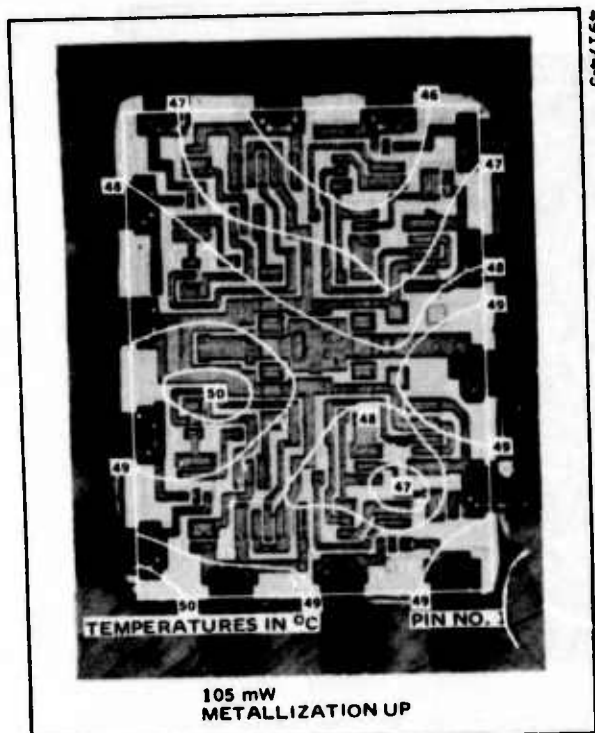
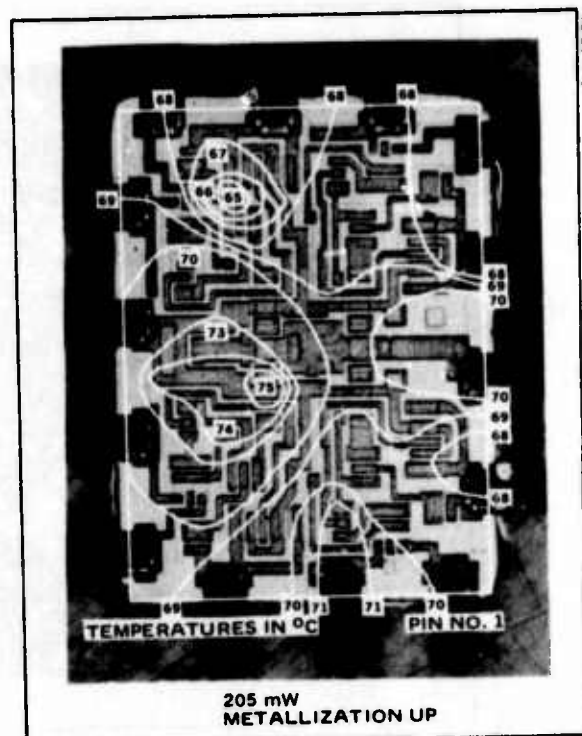
The data shown for Figures 27 and 28 demands further analysis. For instance, Figure 28 shows a hot spot developing (with an increase in power) near left-center of device, while a "cold" spot is developing in upper left area. Figure 29 shows the expected temperature distribution of a device so mounted.

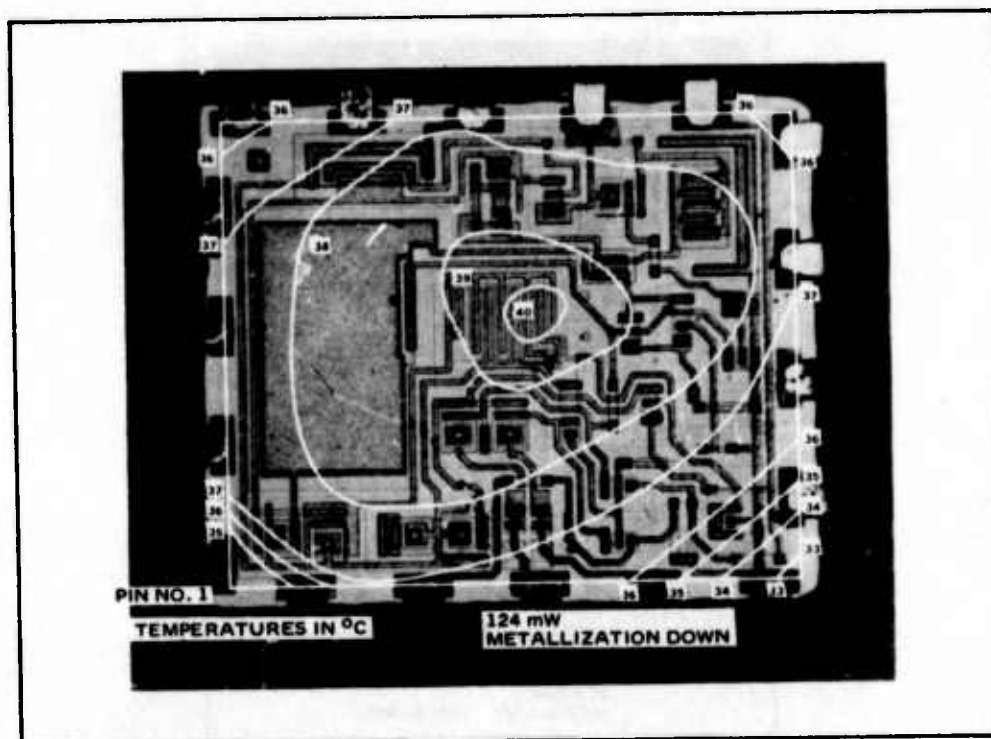
Figure 31. Analog Amplifier Beam Lead Device SC152, S/N 1

This figure shows the expected temperature distribution for these conditions. Note the gradients in lower corners and the relatively uniform temperature over most of the surface area.

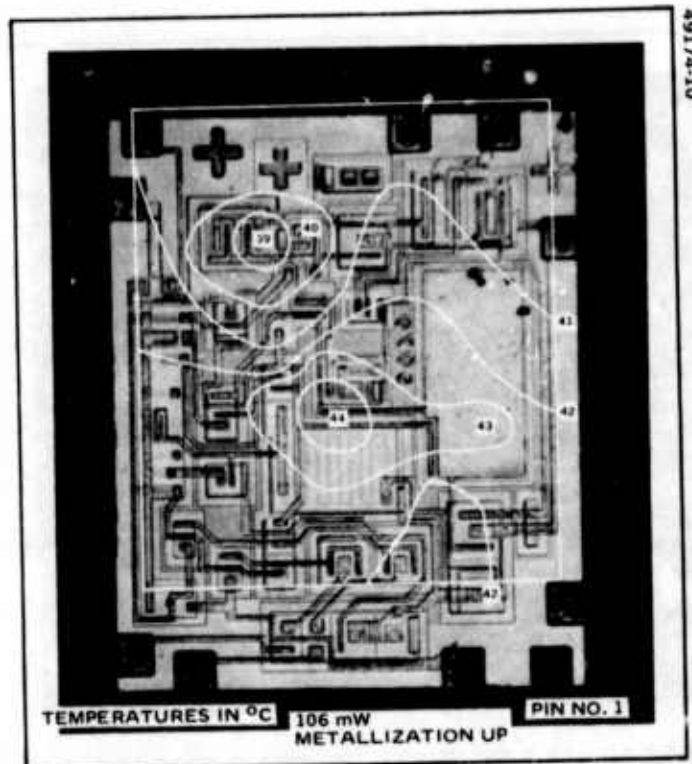
Figure 32. Analog Amplifier Beam Lead Device SC153, S/N 1

As expected, a warm area is indicated over the resistor in the center of the device in Figure 32. In Figure 33, only 3°C temperature range for the entire device is noted.

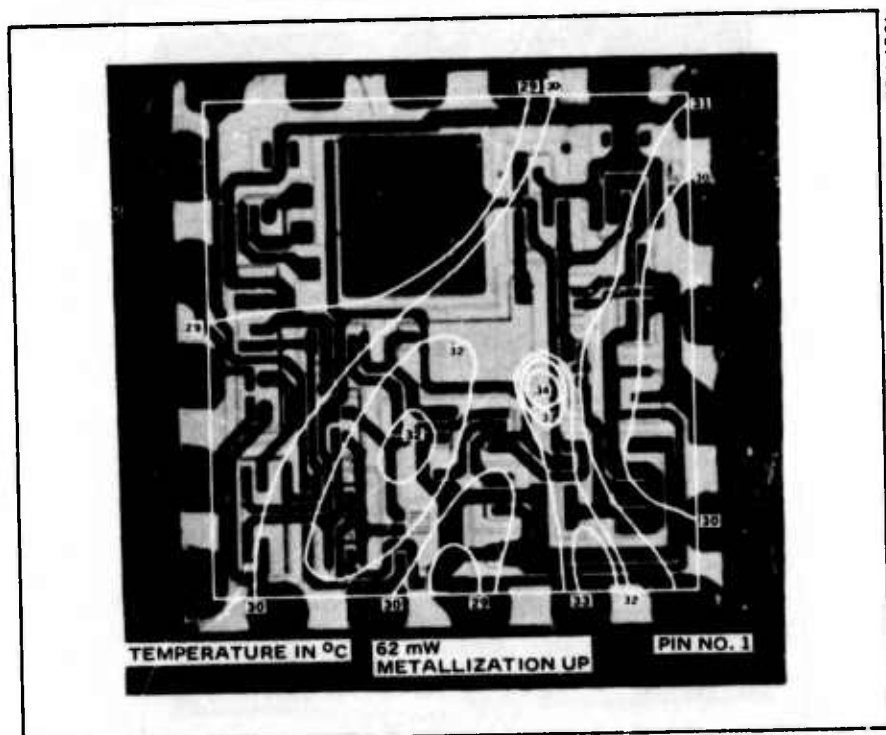
Figure 34. Analog Amplifier Beam Lead Device SC154, S/N 3

The hot spot in Figure 34 may indicate poor termination of resistor in center area. The device in Figure 35 had failed at lower power and no output waveform was present on the oscilloscope. Hot spot in upper right may indicate a poor termination to a beam lead. (A hot spot is also present near the resistor noted on the S/N 3 device shown in Figure 34.)

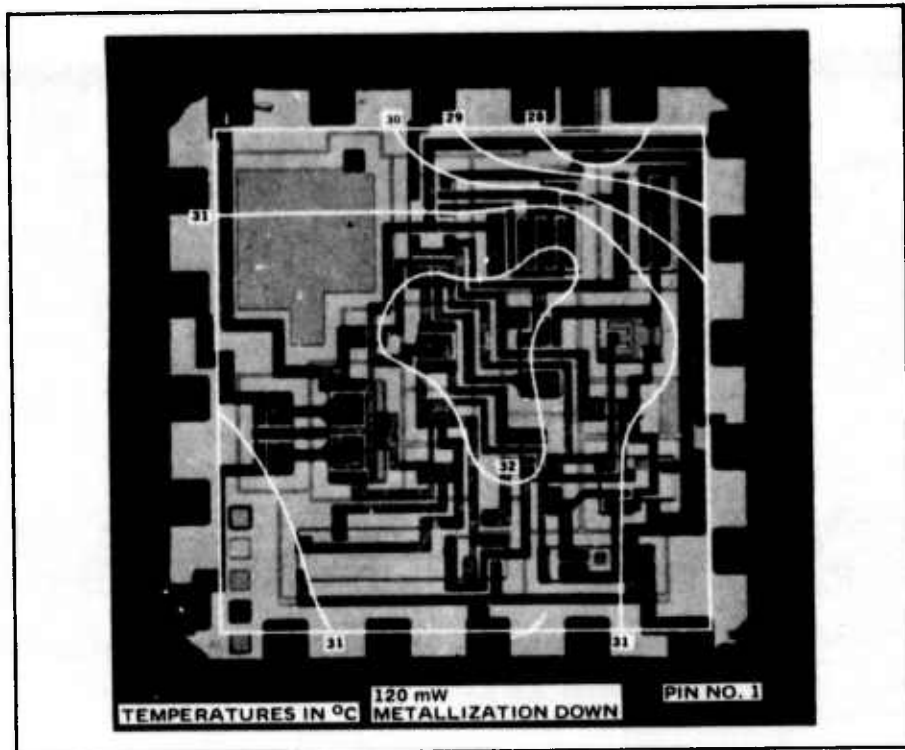
Figure 36. Analog Amplifier Beam Lead Device SC155, S/N 1

In Figure 36, only a 40°C gradient noted. Figure 37 is another instance of data needing further analysis. Comparing Figure 37 (S/N 2) with Figure 36 (S/N 2), it is noted that both devices were mounted in the same manner and under similar voltage conditions. Both devices have a 4°C gradient but S/N 2 indicates more heat concentrated near the output transistor in the upper right, and draws more power.

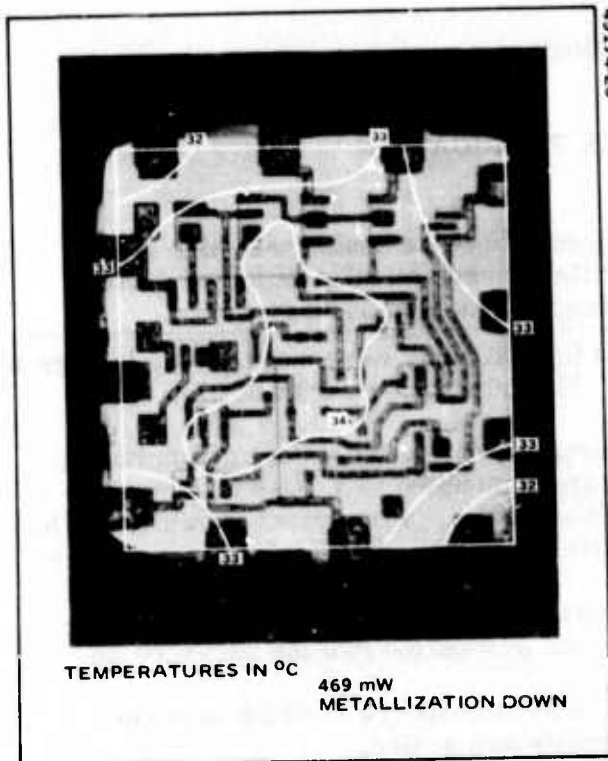
Figure 42. Analog Beam Lead Device SC156, S/N 4

Note increasing gradients due to increased power. Figure 42 shows that a plot can be constructed even though only 2°C gradient occurs.

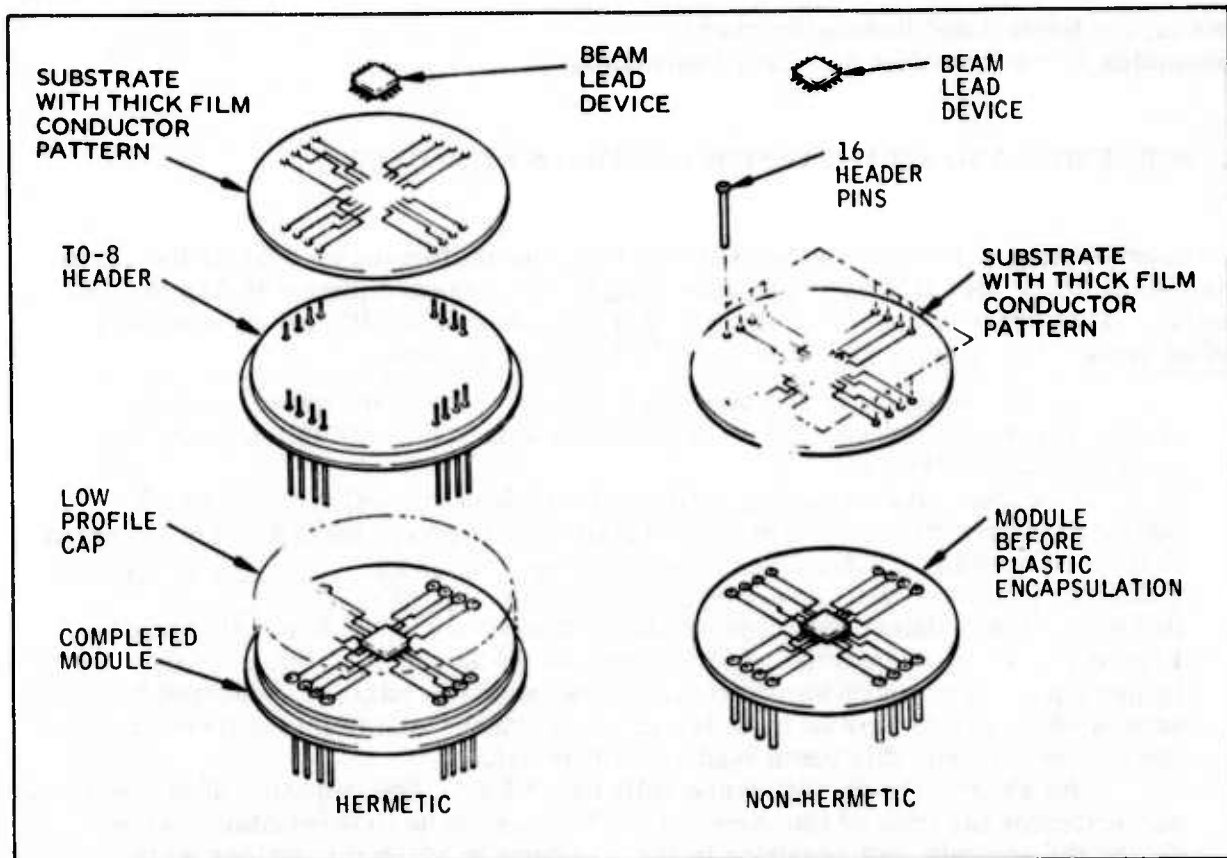
Figure 45. Exploded View of Package Construction. The hermetic devices were cap welded, while one of the non-hermetic devices was conformally coated and the other group molded.

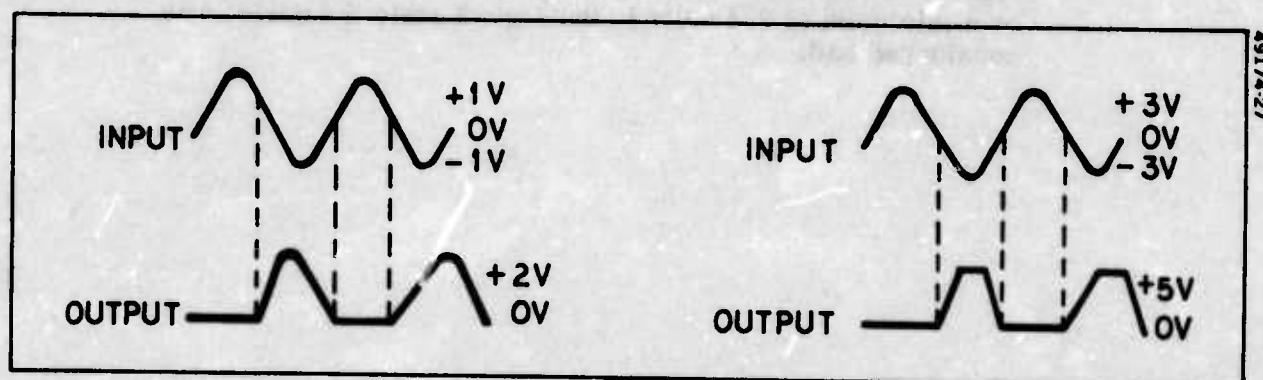
Figure 51. Waveforms for Linear Comparator Circuit

- Test Condition: The output signal should be a positive going, half wave signal, that should clip when it reaches a 5 volt amplitude. Examples of the wave forms are shown in Figure 51.
- Failure Criteria: If the comparator output did not produce these waveforms, or was latched in some mode, the device was considered to be a failure.

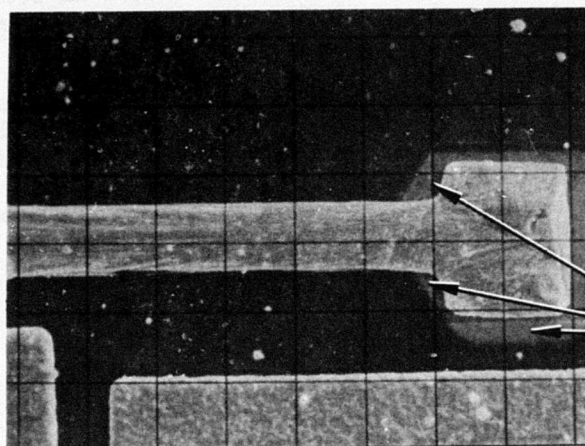
CODE: SC148  
 CLASS: DIGITAL  
 VENDOR: W  
 TYPE: 5473  
 FUNCTION: DUAL J-K FLIP-FLOP  
 PACKAGE: HERMETIC-N<sub>2</sub>  
 MAGNIFICATION: 1000X  
 SCREEN FAILED: FIRST ELECTRICAL TEST

Figure 55. SC148 with Blown Diode Showing Surface Diffusion of Gold

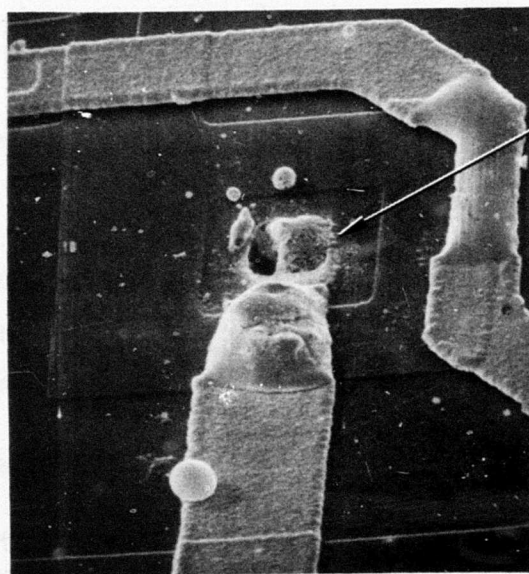
Figure 56. SC152 with Shorts, Melted Gold, Blown Junctions

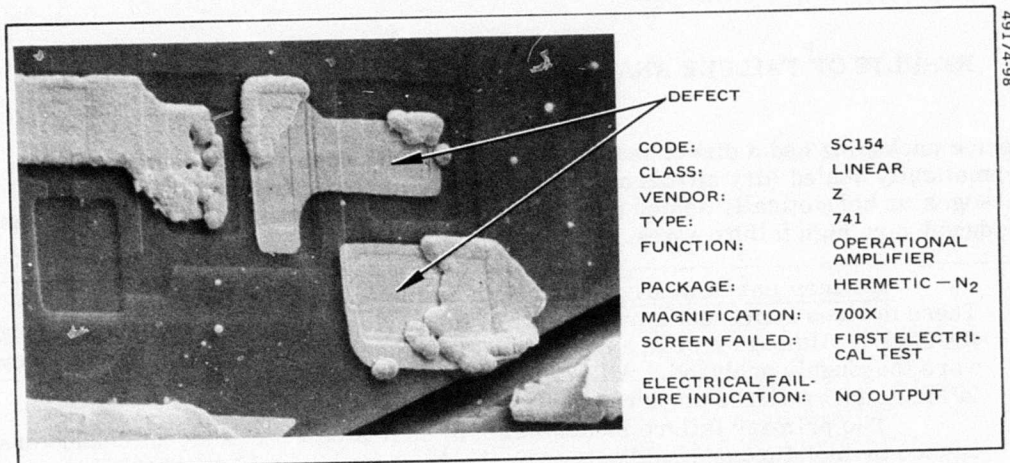
Figure 57. SC154 with Missing Gold Interconnects

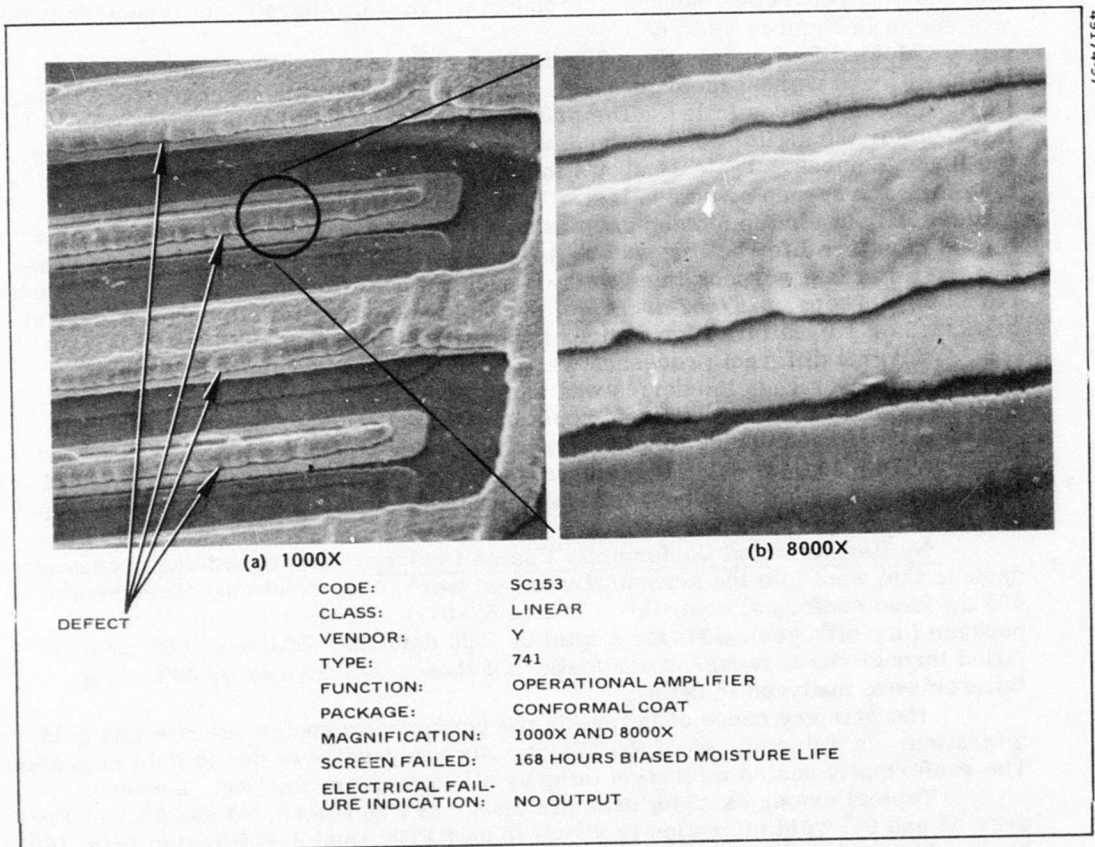
Figure 58. SC153 with Gold Interconnect Plating Anomaly

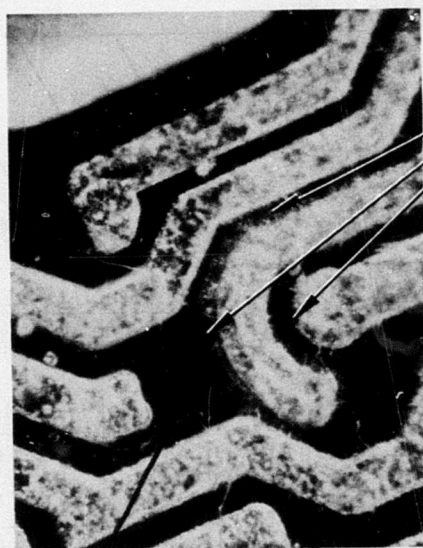
Figure 59. SC149 with Gold Migration

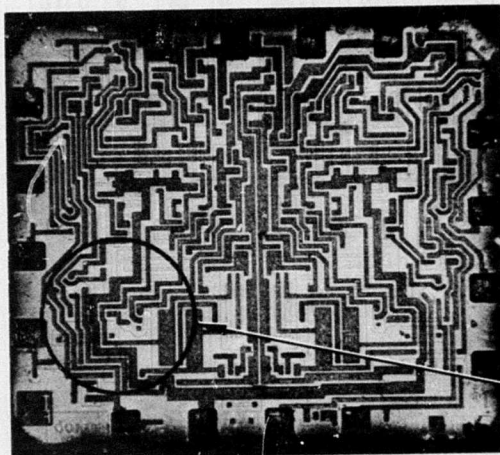
CODE: SC149  
 CLASS: DIGITAL  
 VENDOR: X  
 TYPE: RF100 BL  
 FUNCTION: DUAL J-K FLIP-FLOP  
 PACKAGE: HERMETIC - DI WATER  
 MAGNIFICATION: 200X  
 SCREEN FAILED: 168 HOURS HIGH TEMPERATURE REVERSE BIAS  
 ELECTRICAL FAILURE INDICATION: STUCK LOW

Figure 60. SC149 with Arcing Between VCC Line and Adjacent Interconnect

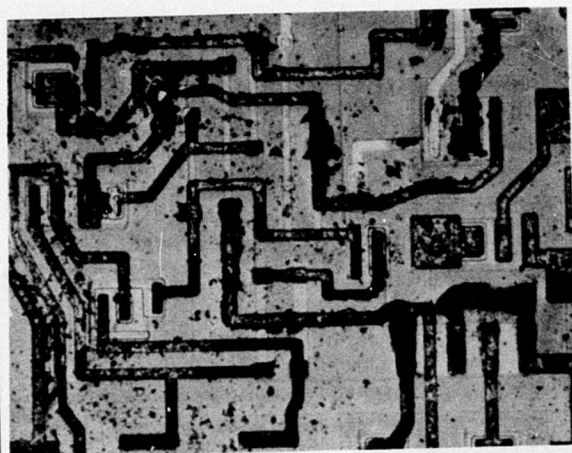
CODE: SC156  
 CLASS: LINEAR  
 VENDOR: W  
 TYPE: 710  
 FUNCTION: VOLTAGE COMPARATOR  
 PACKAGE: HERMETIC — SALINE SOLUTION  
 MAGNIFICATION: 200X  
 SCREEN FAILED: FIRST ELECTRICAL TEST  
 ELECTRICAL FAILURE INDICATION: STUCK HIGH

Figure 61. SC156 with Corrosion (Across Entire Surface)

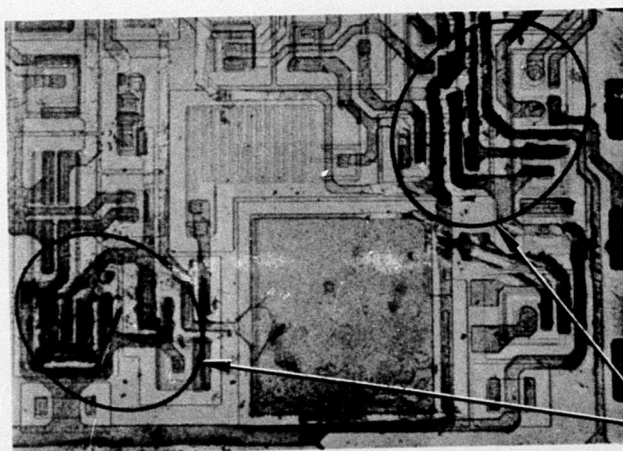
CODE: SC154  
 CLASS: LINEAR  
 VENDOR: Z  
 TYPE: 741  
 FUNCTION: OPERATIONAL AMPLIFIER  
 PACKAGE: HERMETIC — SALINE SOLUTION  
 MAGNIFICATION: 200X  
 SCREEN FAILED: HIGH TEMPERATURE STORAGE  
 ELECTRICAL FAILURE INDICATION: NO OUTPUT

Figure 62. SC154 with Metal Corrosion and Spalling Metal

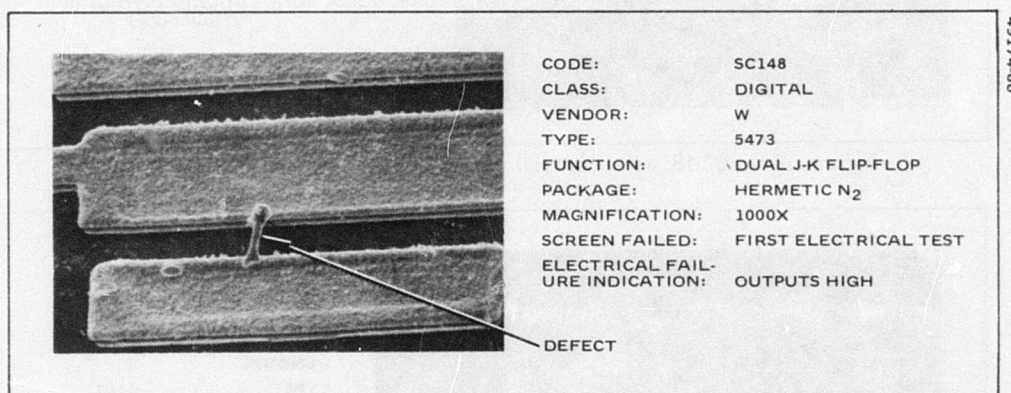
Figure 66. SC148 with an External Short

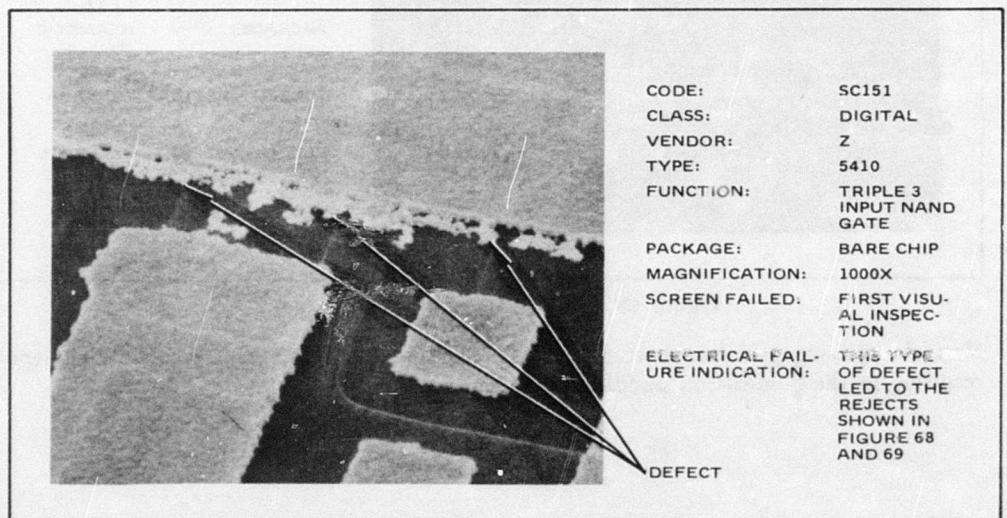
Figure 67. SC151 with Poor Metal Definition

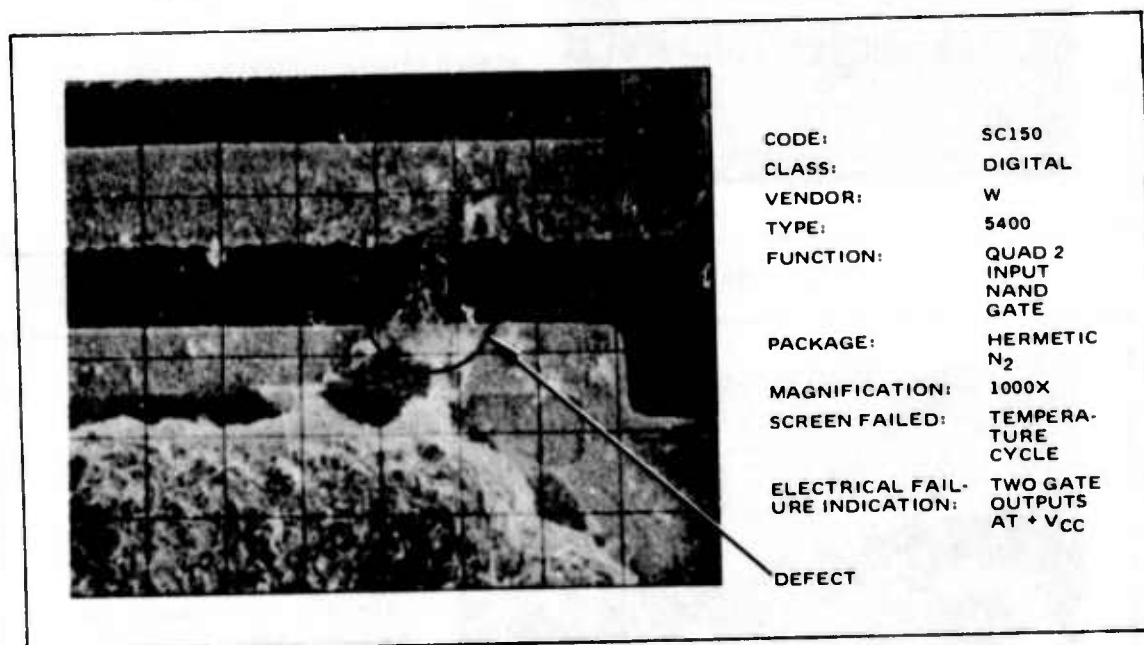
Figure 69. SC150 with Spalling Gold

Here the spalling gold has shorted two adjacent interconnects. This created a hot spot resulting in the gold-silicon puddled area shown

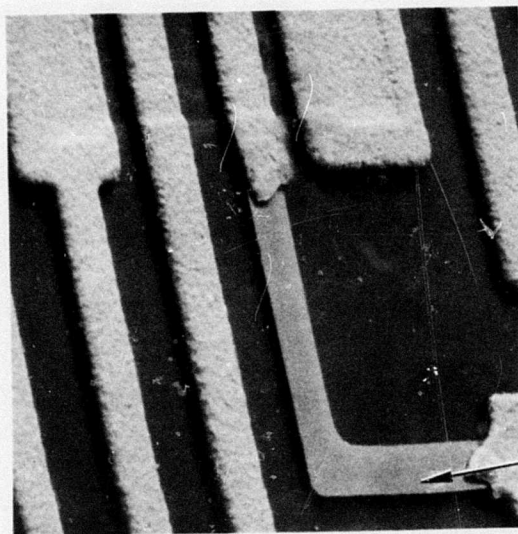
CODE: SC148  
 CLASS: DIGITAL  
 VENDOR: W  
 TYPE: 5473  
 FUNCTION: DUAL J-K FLIP-FLOP  
 PACKAGE: HERMETIC, N<sub>2</sub>  
 MAGNIFICATION: 1000X  
 SCREEN FAILED: THERMAL SHOCK  
 ELECTRICAL FAILURE INDICATION: FLIP-FLOP DOES NOT TOGGLE  
 OUTPUTS STUCK IN "0" LOGIC LEVEL

Figure 70. SC148 with Gold Delamination Resulting from Thermal Shock

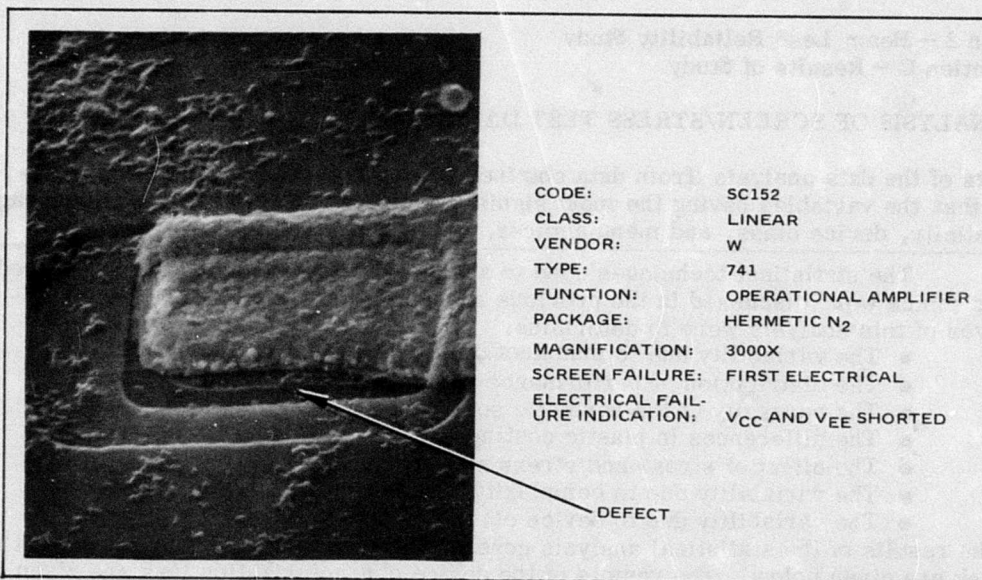
Figure 72. SC152 with Exposed Junction. Although this particular unit was from the N<sub>2</sub> hermetically sealed group, the majority of the exposed junction failures were from the conformally coated and molded package groups. Here, as moisture and other contaminants invade the junction areas, the junction becomes electrically leaky or fails due to metal migration through discontinuities in the platinum. Metal migration in beam lead devices through this mode has been reported by other researchers.

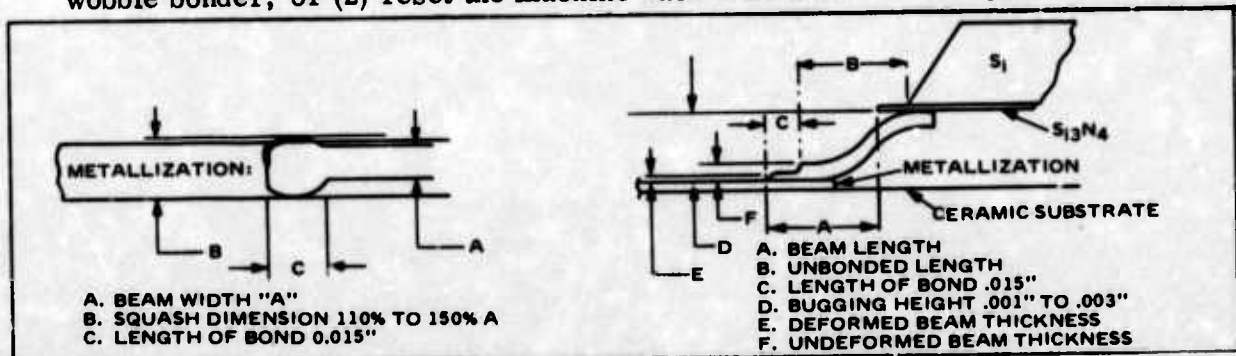
Figure 73. Beam Lead Bond Visual Acceptance Criteria. The ideal footprint of a beam lead device bonded to a conductor or substrate is indicated principally by dimensions C and E. The size and shape of this footprint determines the physical and electrical characteristics of the bond.

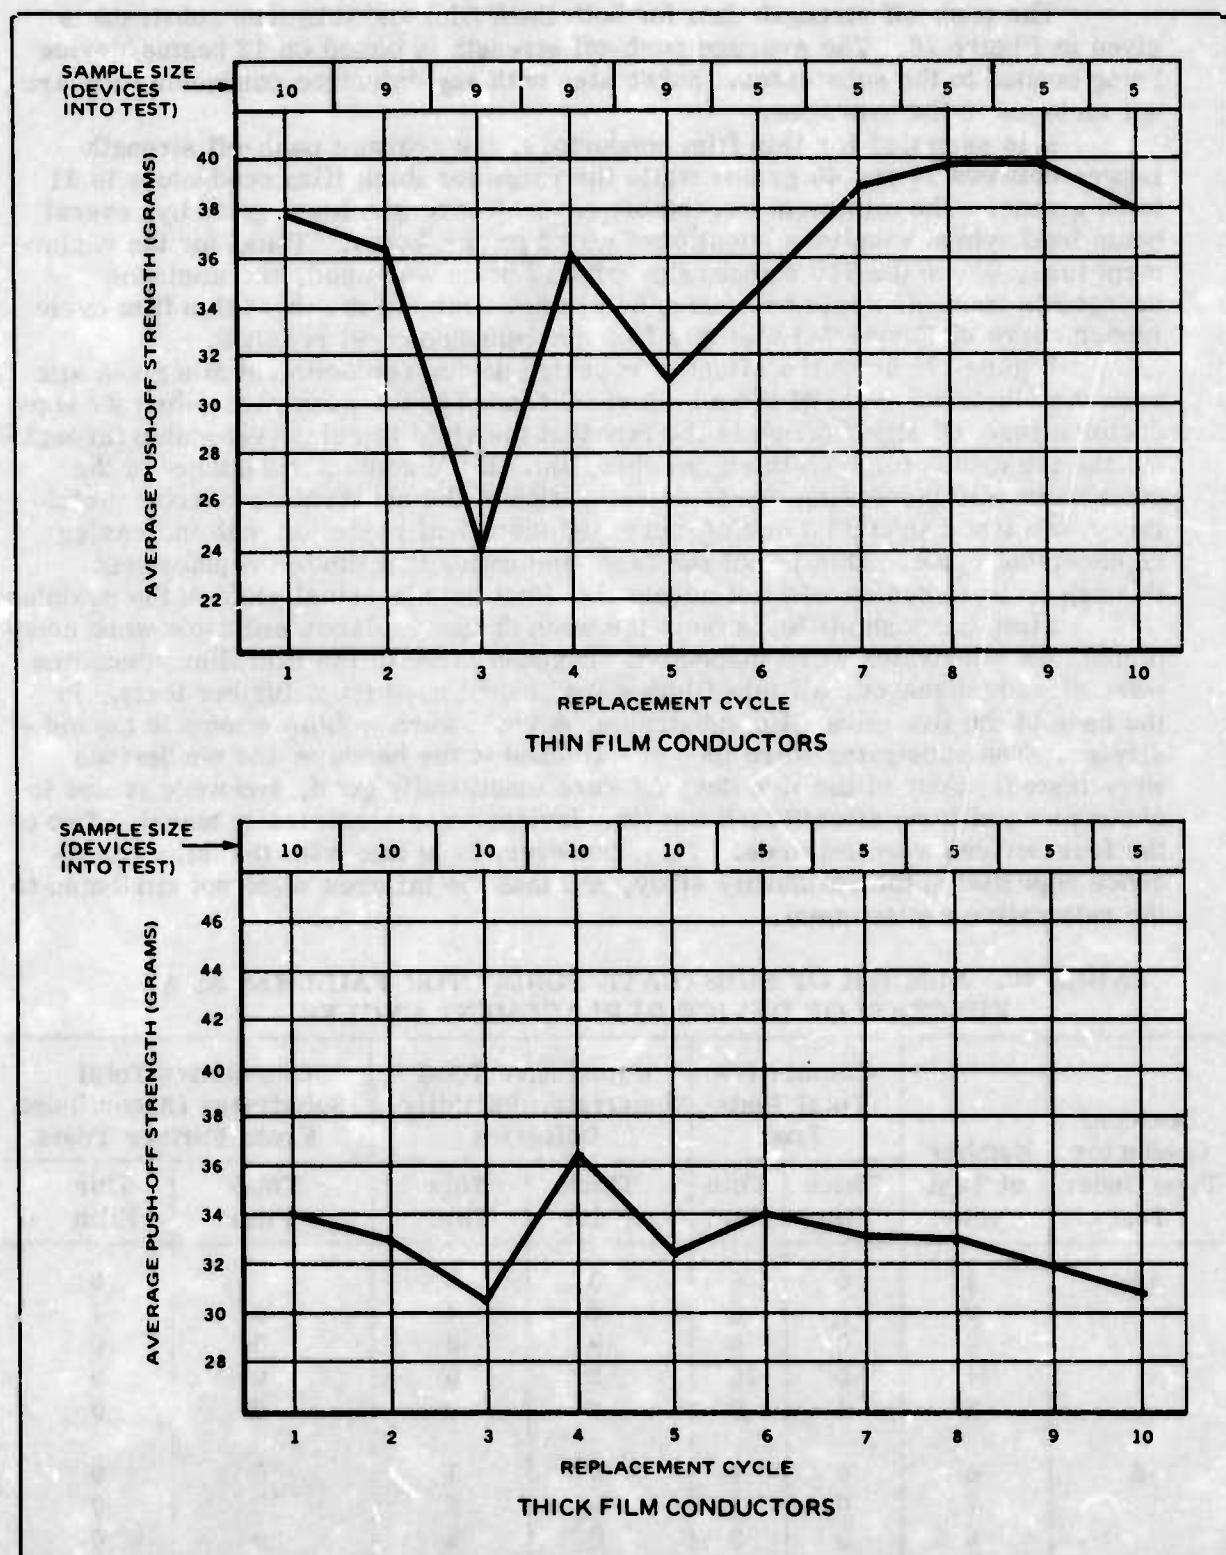
Figure 76. Device Push-Off Strength as a Function of Number of Times Repeated

Device Under Test: Class, Linear; Type 710; Function, Voltage Comparator;  
Vendor, B; Number of beams, 12.
